Manhole Inspection Summary

Manhole # S43EE_015MH

Insp Date: **6/9/09 1:51 PM**

Location Address: **1053 BROADWAY ST**

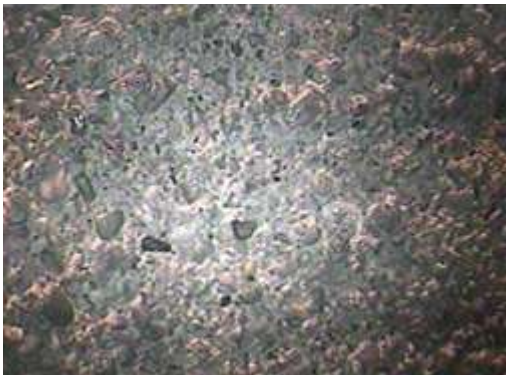
Defect 4

AGGREGATE SHOWING IN BARREL

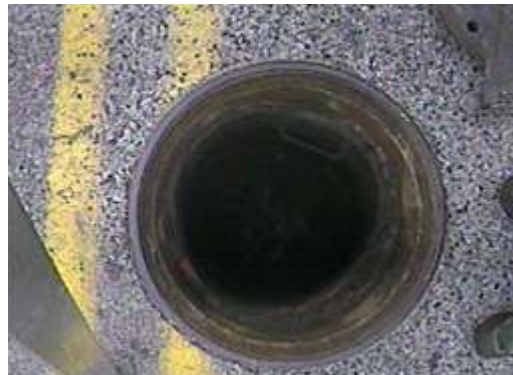
Defect 3

Count: **5** Missing: **5** ☒ **Corroded**

Corroded steps

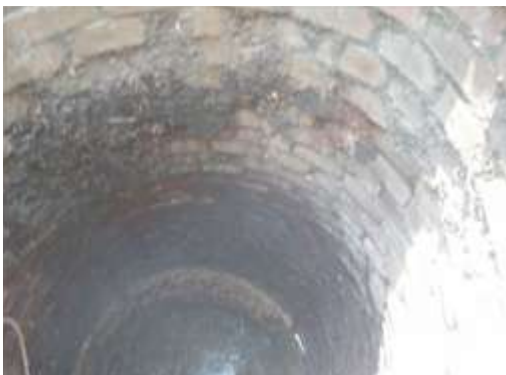
Defect 2

Condition: ☐ Sound ☐ Cracked ☐ Root Intrusion ☐ Loose Brick ☒ **Deteriorated**

Deteriorated barrel

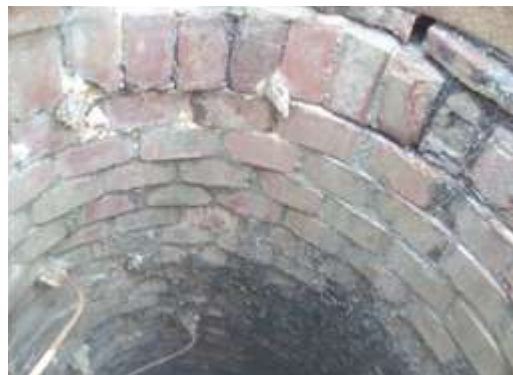
Defect 1

Condition: ☐ Sound ☒ **Cracked** ☐ Root Intrusion ☒ **Loose Brick** ☐ Deteriorated

Cracked chimney

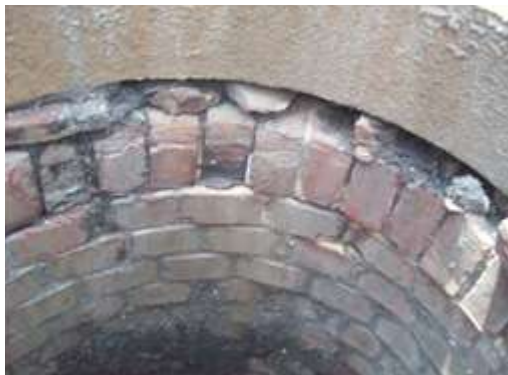
Loose bricks

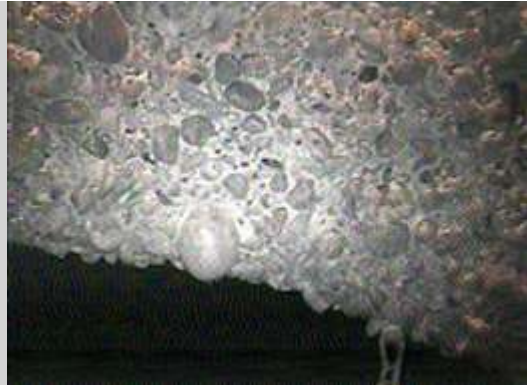
12 O'Clock Outflow

72 in. Circular Gravity Sewer
Pipe Out @ 12 O'Clock

Pipe Height: (in.) Direct
Pipe Material: **Concrete** ☐ Pipe Lined
Invert Depth: **10.74** (ft.) Flow Characteristics: **Fast**
Deposits: ☐ None ☐ Mud ☐ Sludge ☒ **Debris** ☐ Grease
Silt Depth: **30** (in.) Deposits Extent: **Medium**
Infiltration: **None** Pipe Seal Cond: **Sound**

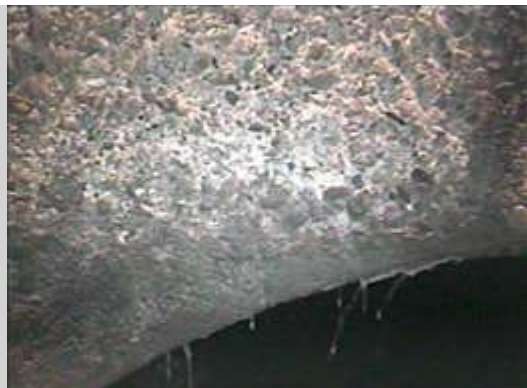
6 O'Clock Inflow

72 in. Circular Gravity Sewer
Pipe In @ 6 O'Clock

Pipe Height: (in.) Direct
Pipe Material: **Concrete** ☐ Pipe Lined
Invert Depth: **10.78** (ft.) Flow Characteristics: **Fast**
Deposits: ☐ None ☐ Mud ☐ Sludge ☒ **Debris** ☐ Grease
Silt Depth: **30** (in.) Deposits Extent: **Medium**
Infiltration: **None** Pipe Seal Cond: **Sound**
